NATIONAL ADVISORY COMMITTEE FOR AERONAUTICS

TECHNICAL NOTE 2632

CORROSION OF MAGNESIUM ALLOY ZK60A IN MARINE ATMOSPHERE AND TIDEWATER

By Fred M. Reinhart

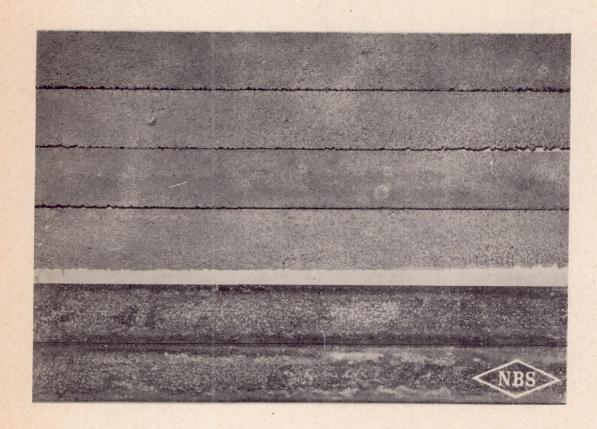
After 6 months of exposure in the tidewater the surfaces of the ZK60A alloy were deeply pitted as shown in figure 1. These surfaces were so irregular and uneven that it was impossible to measure the depths of the pits on the transverse sections by the usual technique. Therefore, to determine the extent of attack it was necessary to measure the thicknesses of sound metal remaining between the bottoms of pits on opposite sides of the specimens. Average values of these measurements are given in table 2. Similar values for AZ31A-H are included to give a comparison of the behavior of the two materials.

In the marine atmosphere both alloys turned dark gray in color and later became speckled with light-gray corrosion products. The products on the ZK60A specimens after 6 months' exposure are shown in figure 1. The depths and widths of the corrosion pits on polished transverse sections of both alloys after exposure to the marine atmosphere are given in table 3.

Figure 1.- Appearance of ZK60A specimens after 6 months of exposure in tidewater (top four) and in marine atmosphere (bottom two, earthward surfaces). X5/8.

The corrosion resistance of the unprotected ZK60A alloy was not so good as that of the unprotected AZ31A-H alloy in either environment. To obtain an adequate service life for any application involving the use of ZK60A in the marine atmosphere for any extended period of time the structure should be well-protected by the application of a good chemical surface treatment and a good paint system.

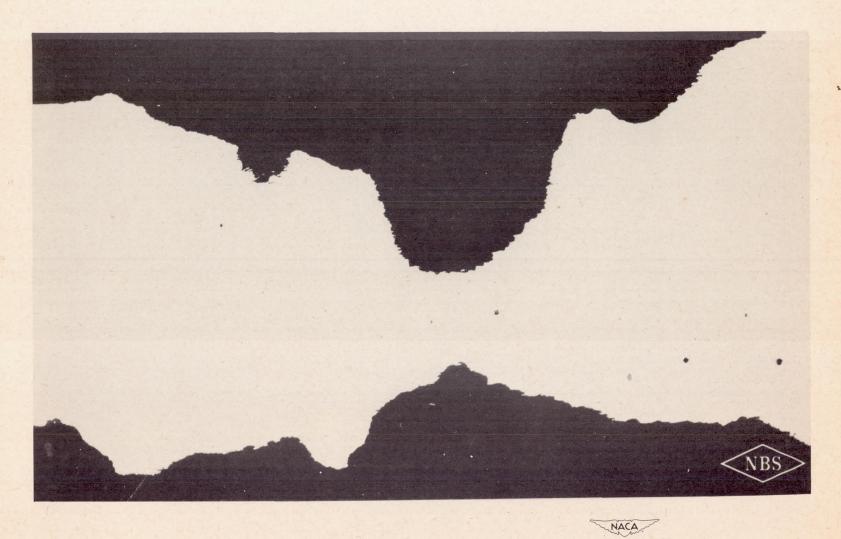
A typical example of the pitting of the ZK60A specimens and the minimum thickness of metal remaining after exposure in the tidewater is shown in figure 2.

It is difficult to make direct comparisons in depths of pits because of the extremely deep pitting and roughened surface of the ZK60A alloy. However, it is apparent from the values in table 2 and from figure 2 that the attack on this alloy was very rapid and severe, considerably more so than that on the AZ31A-H alloy.

Figure 2.- Cross section of specimen of ZK60A alloy showing type of pitting and minimum thickness of remaining metal after exposure in tidewater for 6 months. X100.

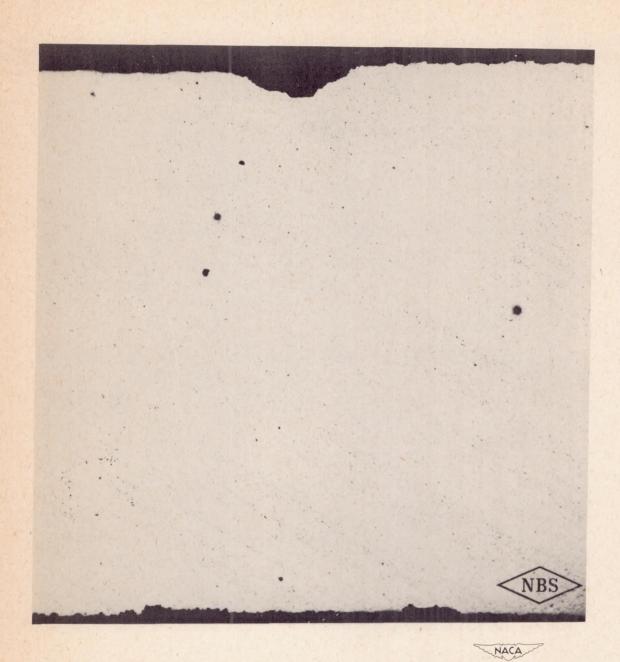
These results indicate that after 6 months of exposure the corrosion pits in the ZK60A alloy were deeper and wider than those in the AZ31A-H alloy. Typical corrosion pits in the ZK60A alloy after 6 months of exposure are shown in figure 3. An idea of the difference in the rapidity of attack between exposure in tidewater and in marine atmosphere can be obtained by comparing the thickness of the remaining metal in figure 2 with that in figure 3.

Figure 3.- Typical pits in ZK60A material after 6 months of exposure in marine atmosphere. Compare thickness of this sheet with that of one in figure 2. X100.

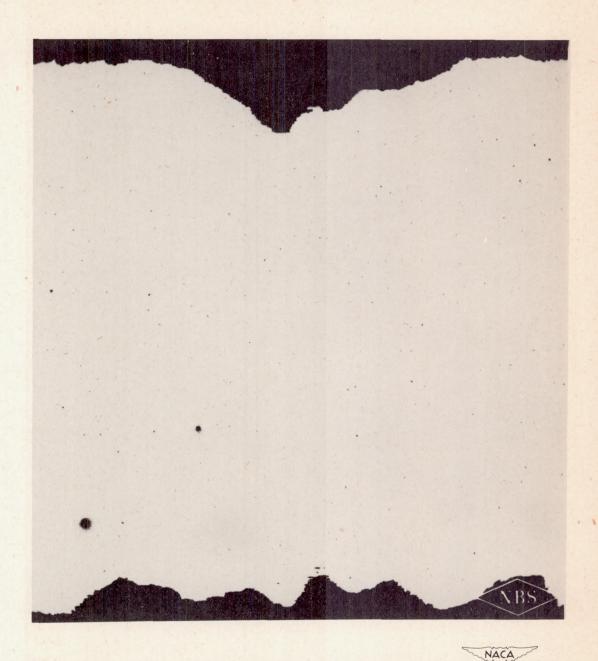
During the next 12 months of exposure, the rate of penetration of the ZK60A alloy decreased but the width of pits increased indicating that the localized attack was becoming less and the general attack was more prevalent. Typical pits in this alloy after 18 months of exposure are shown in figure 4. No comparison could be made with the AZ31A-H alloy because no specimens of the latter alloy were removed at that time.

Figure 4.- Typical pits in ZK60A material after 18 months of exposure in marine atmosphere. Compare thickness of this sheet with that of one in figure 2. X100.
